Historic Property Evaluation Report

31-35 South Main Street, Norwalk, CT

Prepared By:
Jan Hird Pokorny Associates, Inc.
39 West 37th Street, Floor 12A
New York, NY 10018

20 December, 2022

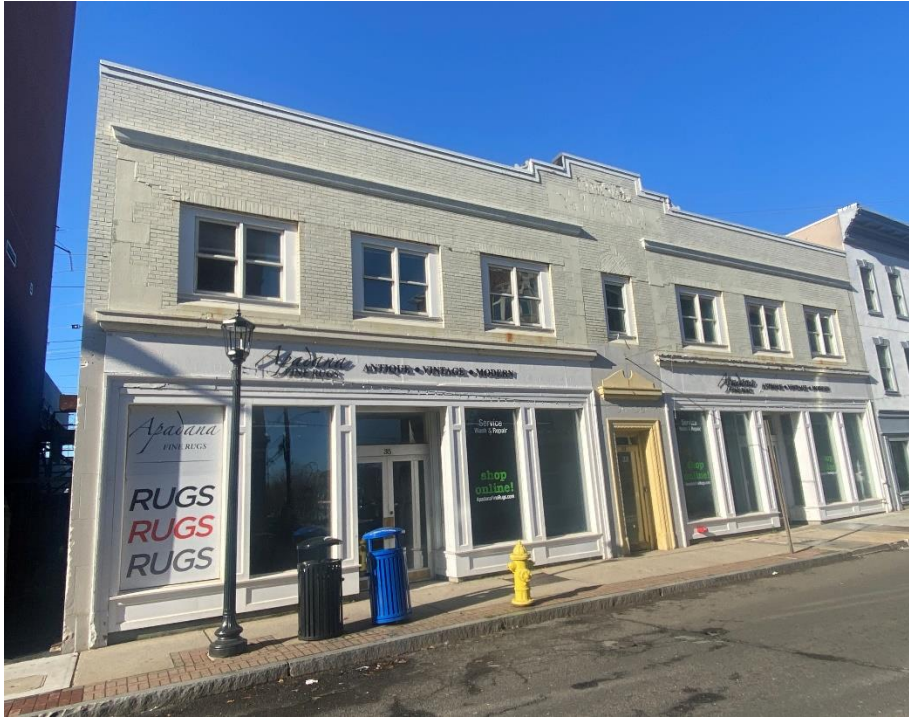
The building appears to have undergone a renovation within the last 20-25 years. The renovation (or a later intervention) included: removal of the original storefronts and replacement with new wood and glass elements that are much less articulated than the originals, replacement of the central main entry door, replacement of second floor windows. The work also has included complete painting of the building facade, which appears to have concealed a number of building deficiencies and deterioration as noted in the following conditions (Photo 1).

In order for the building to return to its original appearance, removal of the extant paint will be necessary. Paint removal will reveal a great number of deficiencies, both structural and cosmetic, that will impact the historical integrity of the building.

Photo 1 Paint obscures much of the damage and deterioration on the building façade

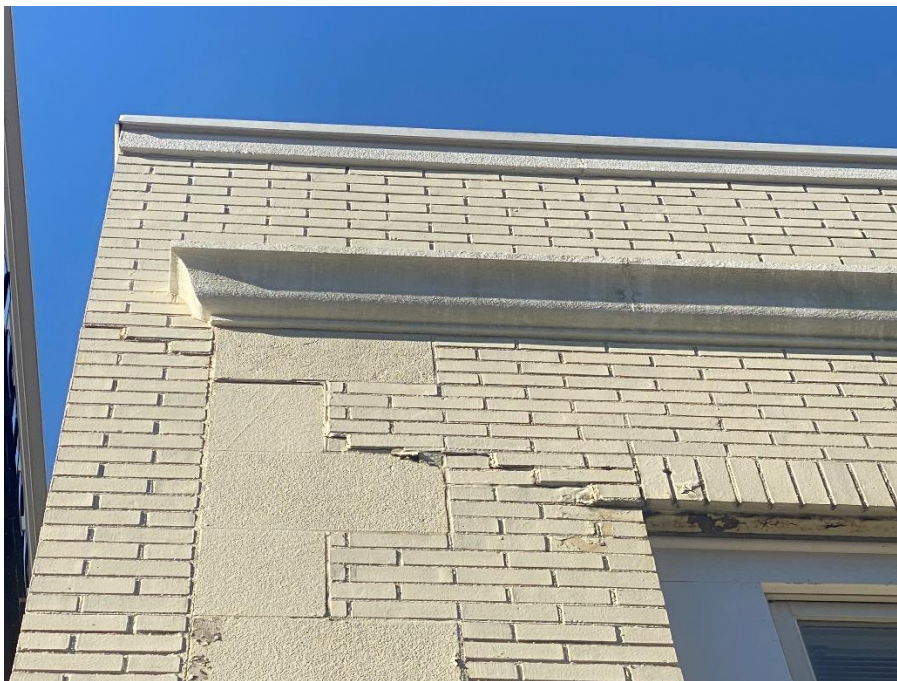
Paint has failed on the façade bricks at some locations. Serious displacement of the brick masonry above the second floor level window level has occurred, which appears to be a result of corrosion and oxide jacking of the steel lintels at the window heads. The masonry displacement is severe at some locations and may present a hazard to public safety (Photo 2).

It is likely that repair of the brick masonry will be problematic and not result in a successful “restoration”. Removal for salvage of the bricks above the lintel level without damage will be difficult, as they are laid in Portland cement mortar, a tenacious, rigid material that will not be able to be removed without damage to the bricks, thus a considerable amount of original masonry will be lost.

Photo 2 Oxide jacking of steel has resulted in serious damage to brick and stone masonry.

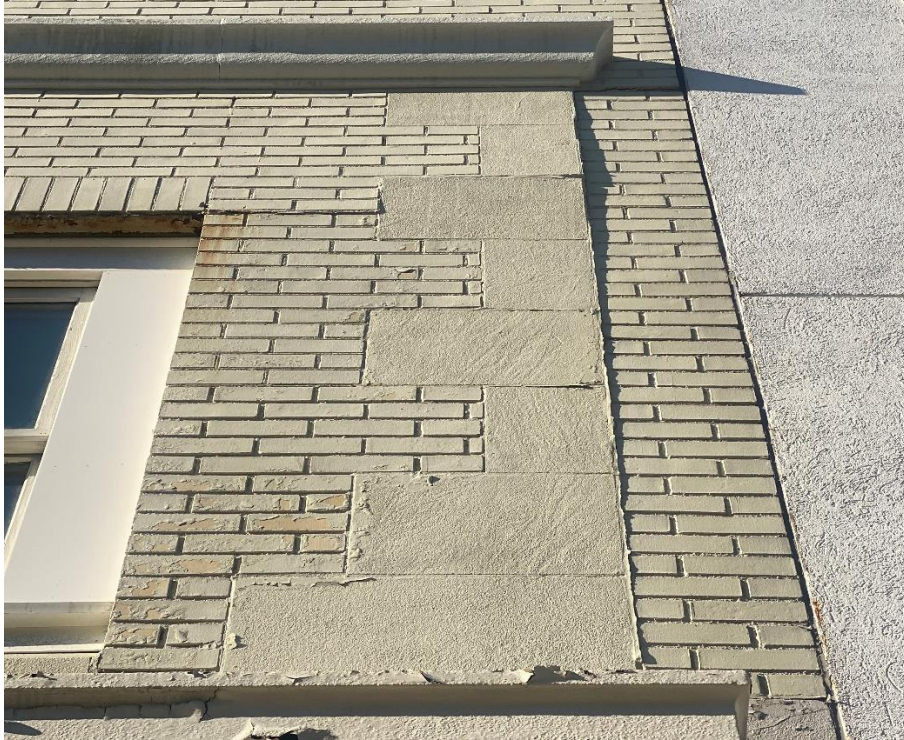
As with the brick masonry above the second floor level window level, limestone quoins are severely displaced and will be difficult to salvage and reuse without damage – resulting in a considerable amount of replacement (Photo 3).

Photo 3 Stone masonry has been seriously displaced and presents a hazardous condition

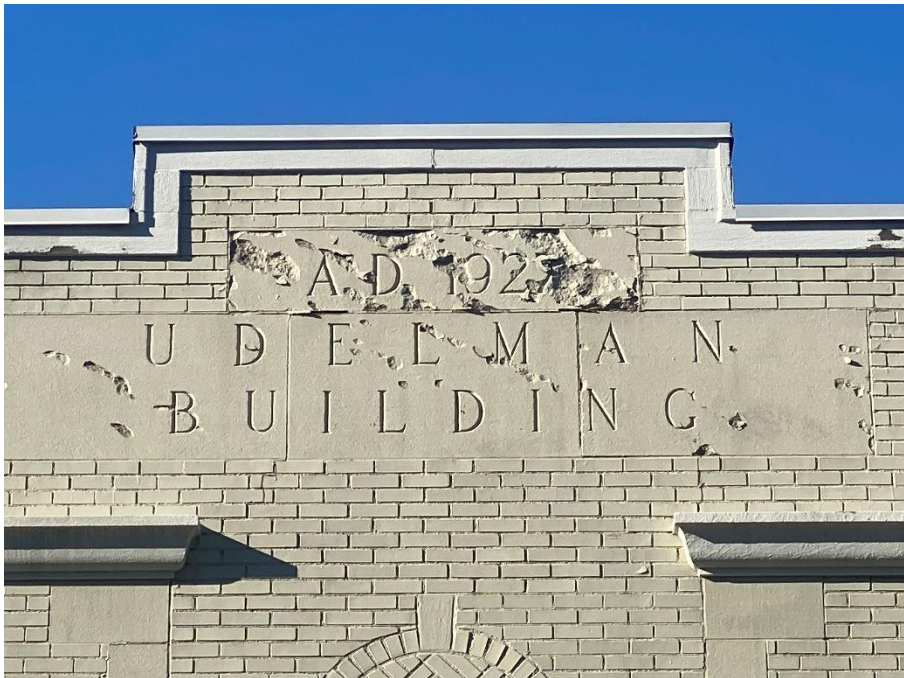
At the central pediment inset name and date panel limestone, there is a significant amount of stone spalling (Photo 4). The disfigured stone obscures the date of construction, and is visually obtrusive. At the parapet coping level, the copings have been covered with sheet metal that may be concealing damage, and the two stone scrolls that flank the stepped pediment have been covered with asphaltic material. At the limestone string course above the storefront sign band the original limestone cornice above the 31 Main St storefront appears to have been replaced with a ferrous replacement, which has

Photo 4 Limestone spalling will require significant intervention affecting building integrity

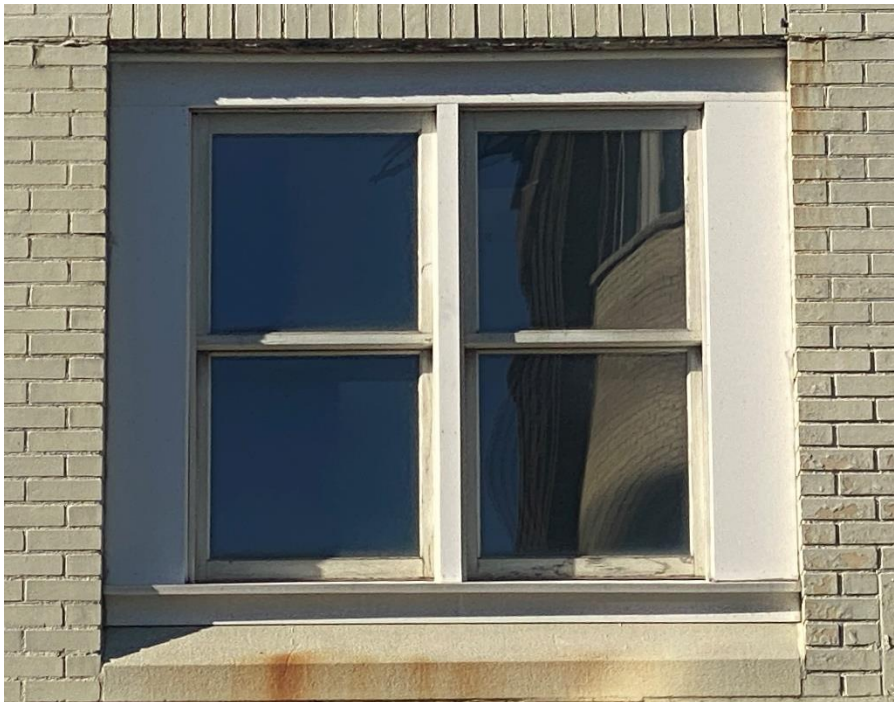
Early photographs reveal that the original windows featured one-over-one hung sash in frames that fully filled the punched openings. The extant windows are one-over-one wood sash, inappropriately smaller than the originals openings, and placed awkwardly off center within the masonry openings - with sheet metal infill panning at the perimeters (Photo 6).

Photo 6 Windows on the building are inappropriate and will require appropriate replacement.
